Manhole Inspection Summary

Manhole # S29S__001MH

Inspection ☐ Is Incomplete Rating: **4) Poor**

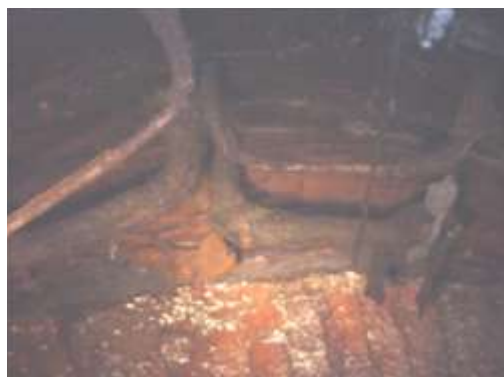
Defect 5

corroded steps with surcharge and barrel infiltration

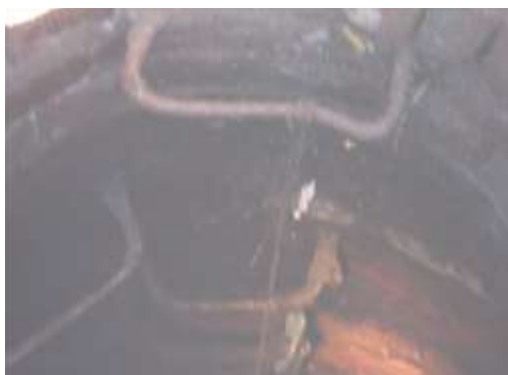
Defect 4

surcharge on steps

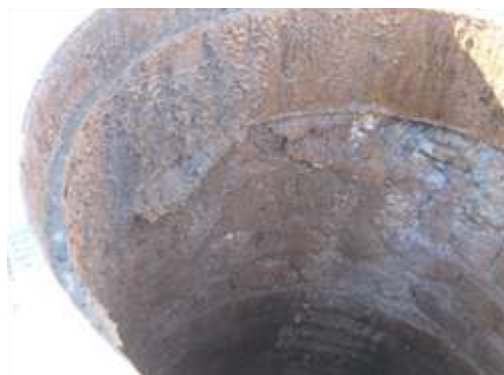
Defect 3

frame, chimney and corbel infiltration (mud depoists)

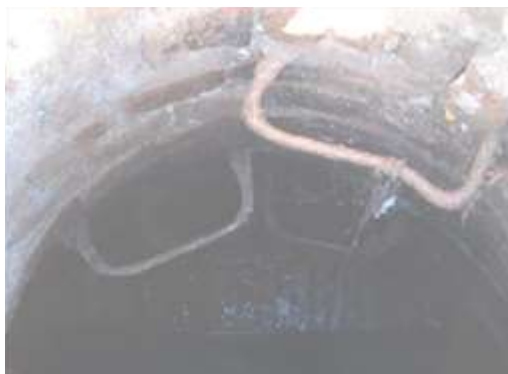
Defect 2

corroded steps

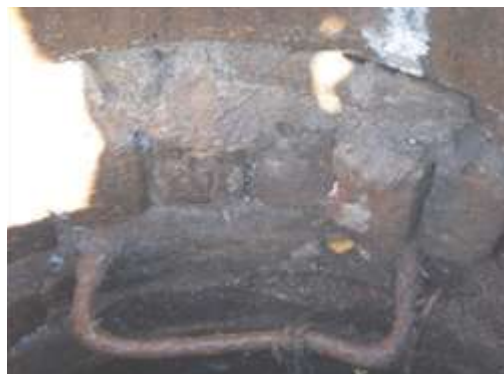
Defect 1

deteriorated chimney, infiltration

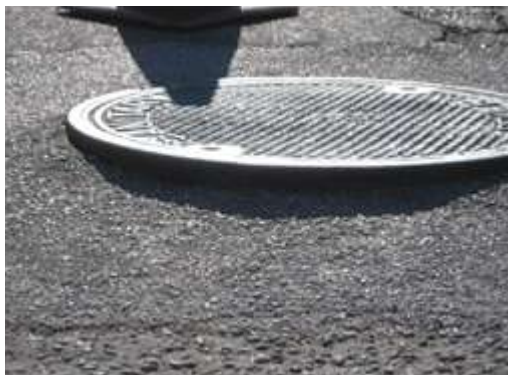
defect 6

above grade

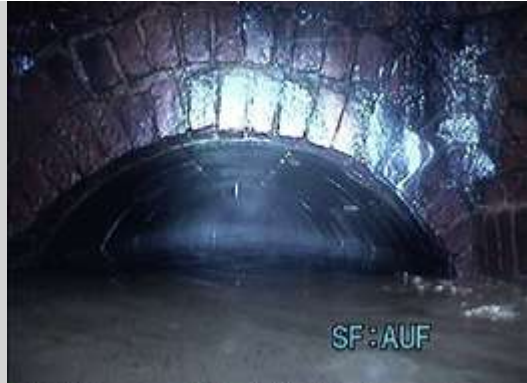
12 O'Clock Outflow

39 in. Circular Gravity Sewer
Pipe Out @ 12 OClock

Pipe Height: **33.6** (in.) Rod and Bar (Angled)
Pipe Material: **Clay** ☐ Pipe Lined
Invert Depth: **11.72** (ft.) Flow Characteristics: **Fast**
Deposits: ☒ None ☐ Mud ☐ Sludge ☐ Debris ☐ Grease
Silt Depth: **0** (in.) Deposits Extent:
Infiltration: **None** Pipe Seal Cond: **Sound**

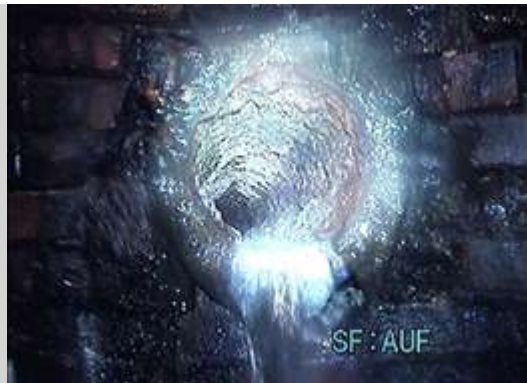
4 O'Clock Inflow

8 in. Circular Gravity Sewer
Pipe In @ 4 OClock

Pipe Height: **10.8** (in.) Rod and Bar (Angled)
Pipe Material: **Clay** ☐ Pipe Lined
Invert Depth: **7.58** (ft.) Flow Characteristics: **None**
Deposits: ☒ None ☐ Mud ☐ Sludge ☐ Debris ☐ Grease
Silt Depth: **0** (in.) Deposits Extent:
Infiltration: **None** Pipe Seal Cond: **Sound**

Drop: **Outside** Rod and Bar
Angled: **Yes** Reading: **8.77** (ft.)
Inv Depth: **9.77** (ft.)

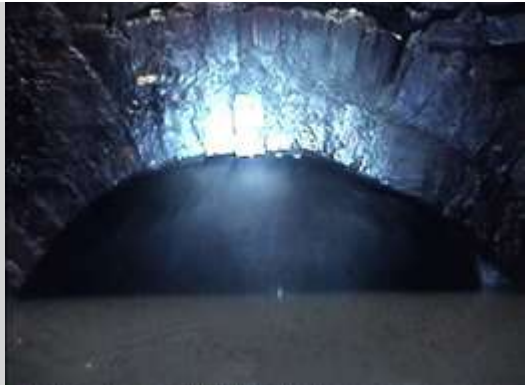
6 O'Clock Inflow

39 in. Circular Gravity Sewer

Pipe Height: **32.4** (in.) Rod and Bar (Angled)

Infiltration: **None** Pipe Seal Cond: **Sound**
